Northumberland County Before and After Pictures for 310 ECE Inspection

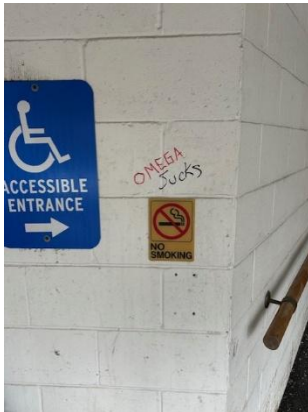
Before:

Graffiti

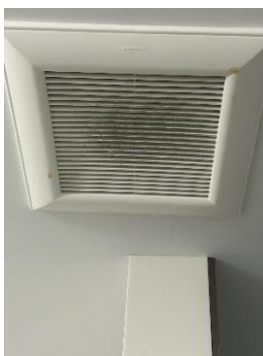
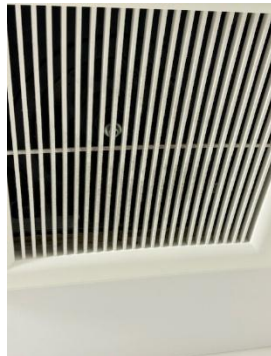
Before:

Vent requiring cleaning (inside)

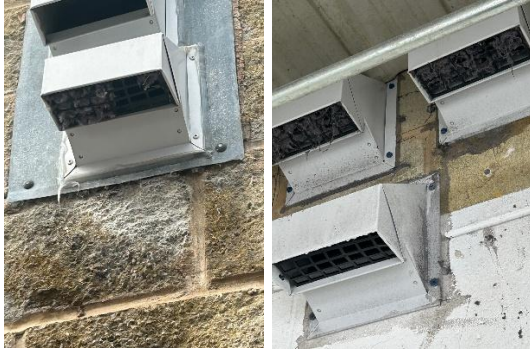
Before:

Vents requiring cleaning (outside)

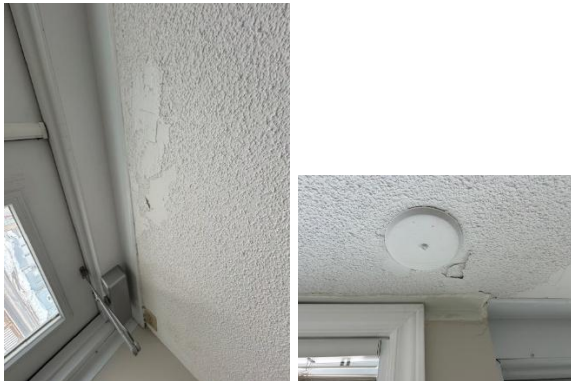
Before:

Peeling Paint

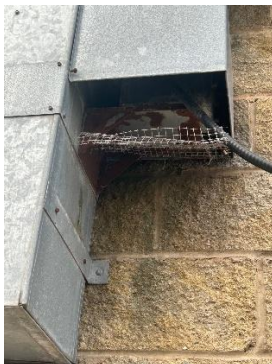
Before:

Outside Mesh Loose

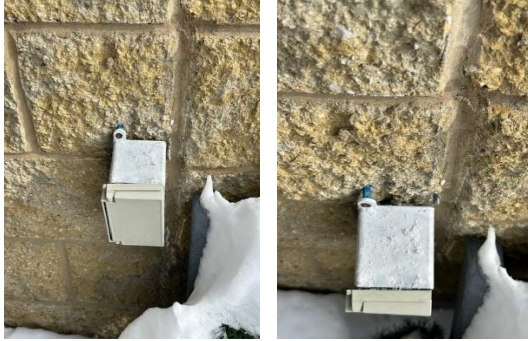
Before:

Outside Electrical Box Loose

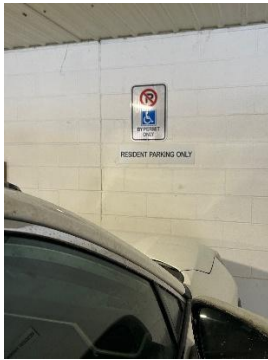
After:

Accessibility Parking Spot:

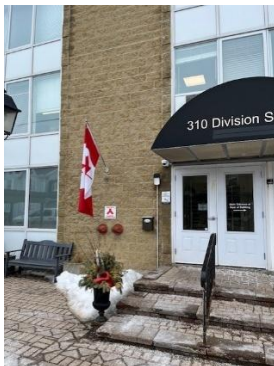
After:

Flagpole:
